EXISTING CONDITIONS PLAN OF KEDDY MILL  
ROUTE 202 WINDHAM, MAINE

FOUNDATION ASSESSMENT AND SEISMIC REVIEW  
KEDDY MILL, SOUTH WINDHAM, ME  
RESURGENCE ENGINEERING PROJECT NUMBER 08-027

FINAL REPORT  
FEBRUARY 11, 2009

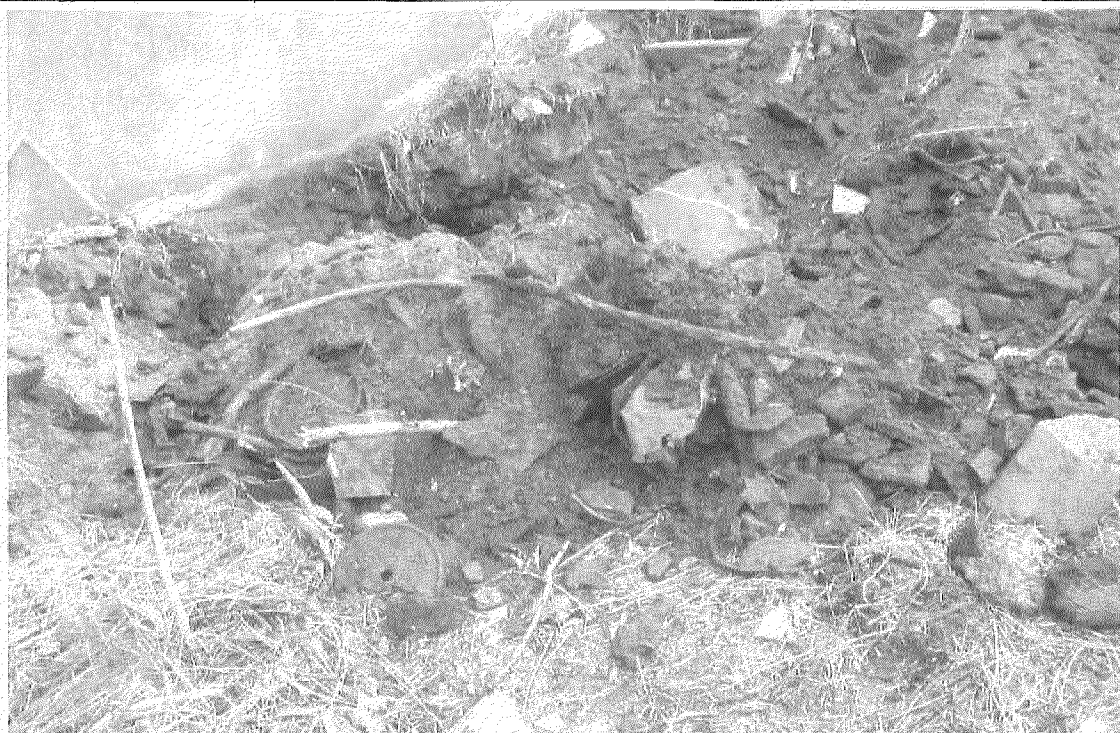
**PHOTO**  
**#4.2**

Keddy Mill: Fill excavated from South Wall Excavation at Pier 24

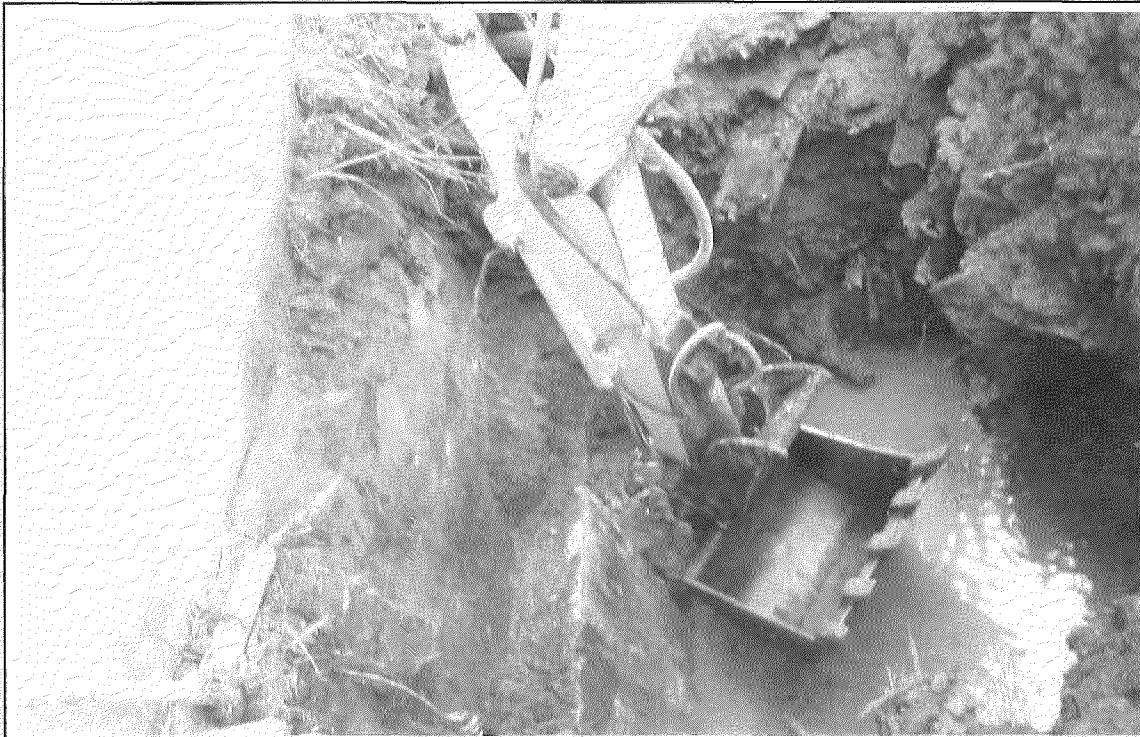
**PHOTO**  
**#4.5**

South Wall Excavation at Pier 24: Note loose fill in excavation.
